## **VII. SAFETY ON ICE: HUMAN FACTORS TRAINING FOR GROUND DEICE/ANTI-ICE PROGRAMS**

Neil C. Krey

This paper has been prepared for distribution in conjunction with the Royal Aeronautical Society's CRM and Ground Operations Conference held at London Gatwick Airport on 5 February 1999. It is based on a presentation made by the author at the 1997 Society of Automotive Engineers (SAE) Ground Deice/Anti-Ice Conference at Pittsburgh, Pennsylvania on 13 June 1997.

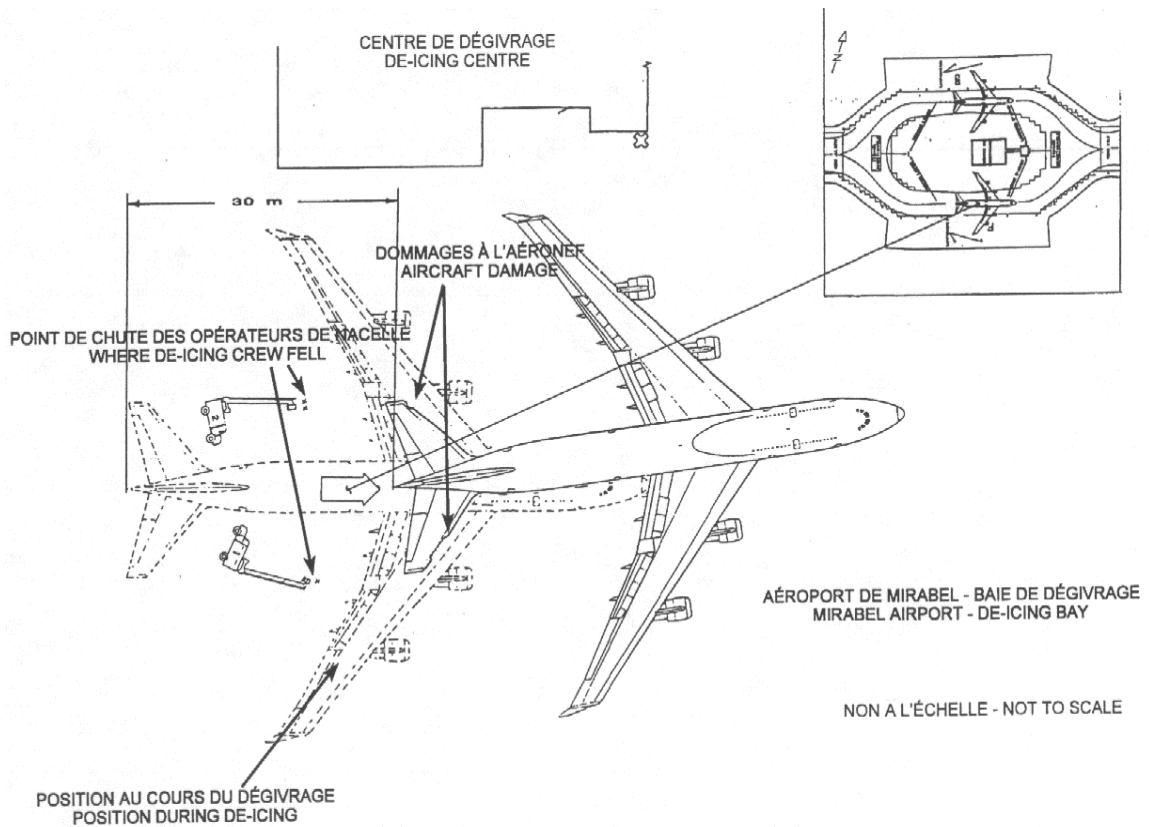
The horizontal stabilizers of the aircraft had struck the telescopic booms of the deicing vehicles, causing the occupants of the cherry pickers to fall and knocking the deicing vehicles over on their sides. The two vehicle drivers sustained minor injuries. The three occupants of the cherry-pickers sustained fatal injuries when they struck the ground.

The Canadian Transportation Safety Board (TSB) determined that the flight crew started to taxi the aircraft before its perimeter was clear, following confusion in the radio communications. They identified the following factors that contributed to the accident:

- a lack of deicing procedures within Royal Air Maroc;
- non-compliance with procedures on the part of the CAIL deicing crew;
- inadequate or inappropriate communications equipment;
- incomplete training of Snowman 1;
- a regulatory framework less demanding of foreign air carriers than of Canadian carriers;
- a lack of operational supervision;
- and a lack of adherence to radio protocol.
